Overheated Engine - Diagnostic Tips

NEW E46 with M54 engine

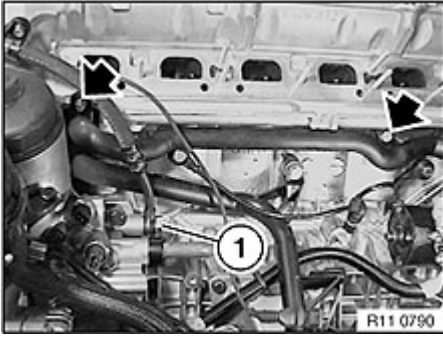
1. Drain the engine coolant. See Repair Manual group 17, section 17 00 005.
2. Remove the intake manifold. See Repair Manual group 11, section 11 61 050.
3. Remove the plastic heater core feed pipe, BMW Part Number 11 53 1 705 210 (located under the intake manifold; see illustration below).

Note: If the coolant pipe cannot be removed after removing the securing hardware (arrows), the VANOS banjo bolt (1) must also be removed, thus allowing the additional clearance needed to remove the pipe.

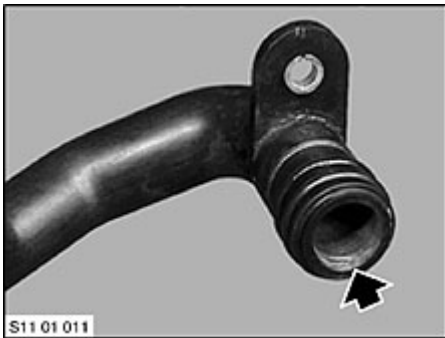
4. Visually inspect the front (inside) of the coolant pipe:

If the plastic on the inside of the coolant pipe shows no signs of deterioration (smooth surface), the engine should be reassembled using new gaskets and O rings, where necessary.

The overheat condition in this case was not severe enough to cause internal damage to the coolant system components.

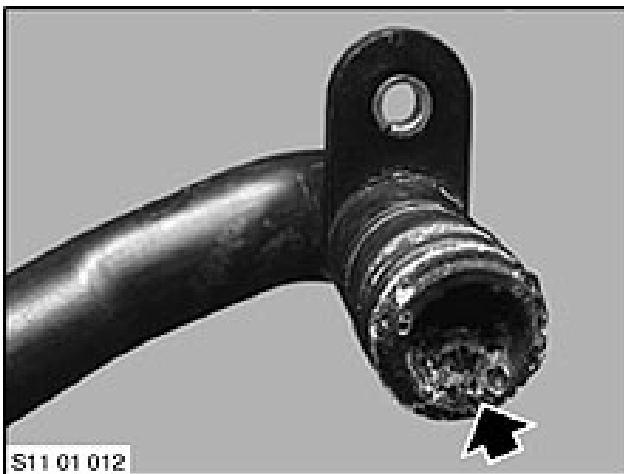
If the plastic on the inside of the coolant pipe shows signs of deterioration (worn away, bubbling, etc.) as shown, this is an indication that the engine has been severely overheated and the components listed below must be replaced.

Important note: If the coolant pipe shown (P/N 11 53 1 705 210) has deteriorated as described above, it must be sent to the Warranty Parts Return Center (WPRC) in Montvale, New Jersey, along with the Warranty Parts Tag for credit and further analysis.

Components to be replaced if the inside of the coolant pipe shows signs of deterioration:

- Cylinder head gasket
- All coolant hoses
- All plastic coolant pipes
- Coolant expansion tank and cap
- Radiator
- Water pump

- Thermostat
- If the engine oil smells burned, it should be replaced, along with the oil filter.
